# RELIC TO RESILIENCE THE GLASS BREAKWATER REPAIR PROJECT

# The Glass Breakwater - Apra Harbor, Guam

- Breakwater protects Port of Guam + Naval Base Guam
- Typhoon Mawar (May 2023) caused severe damage
  - à Apra Harbor Waterfront Repair Project
    - \$571M design-build project (NAVFAC)
    - Comprehensive repair of outer 5,800 ft of breakwater
    - Contractor - TPC-NAN JV (**Black Construction**)
    - Designer - **Baird** (+ AECOM, SEI, Woolpert, CLI, NRC)

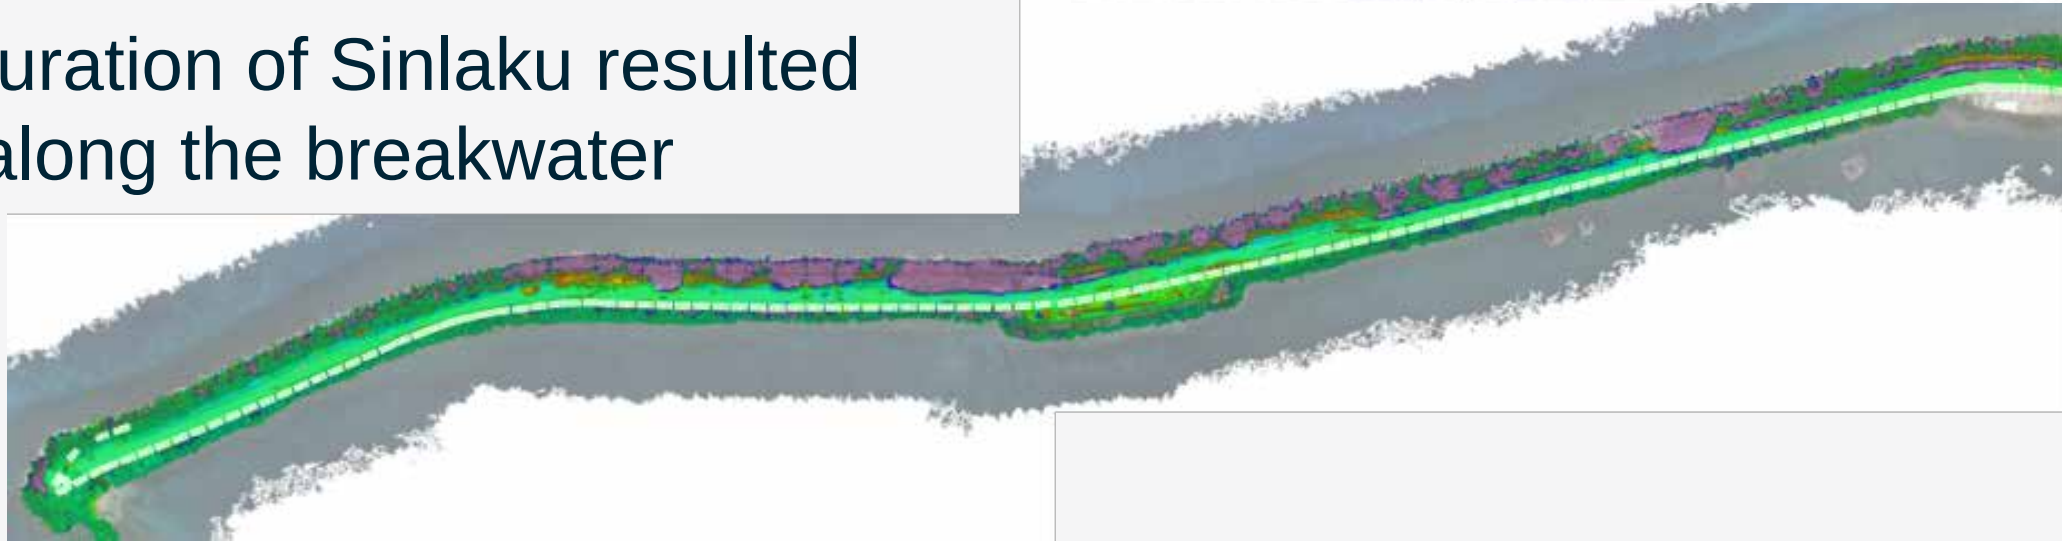
- Extended Duration of Sinlaku resulted in damage along the breakwater

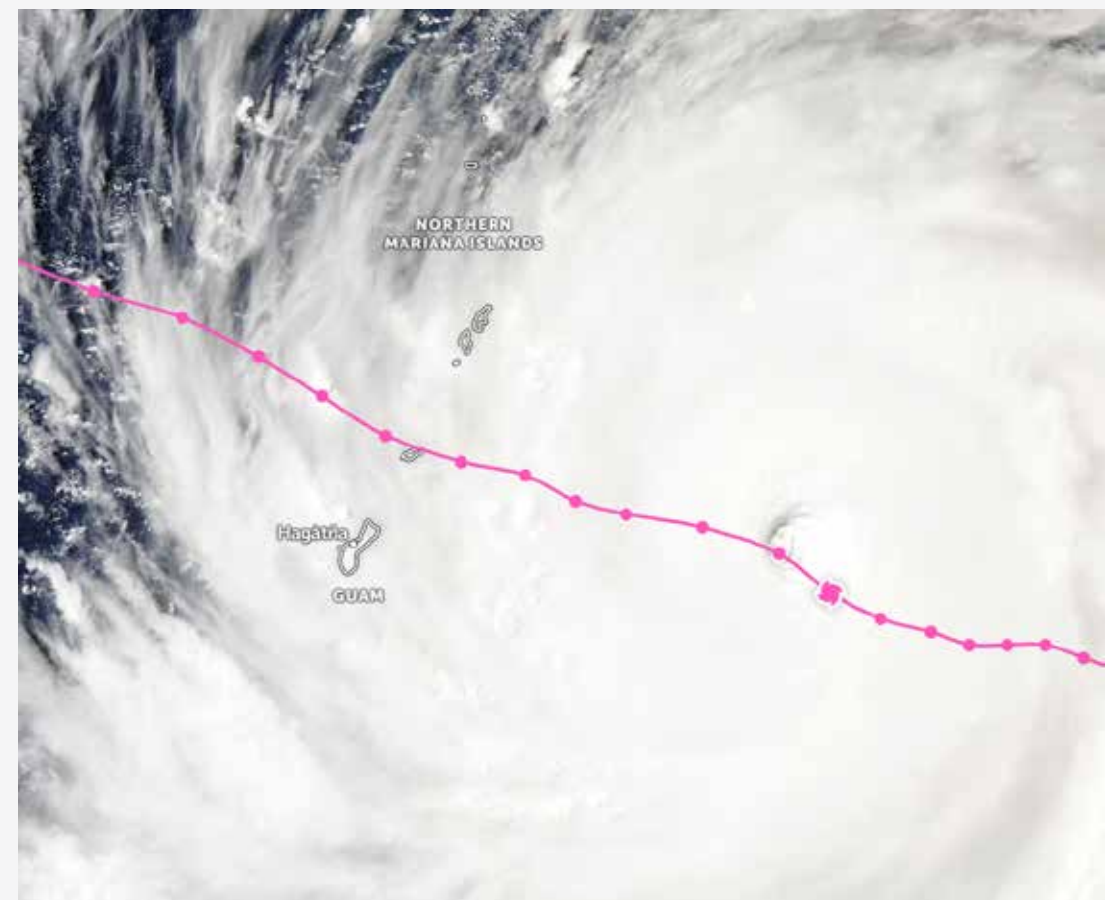
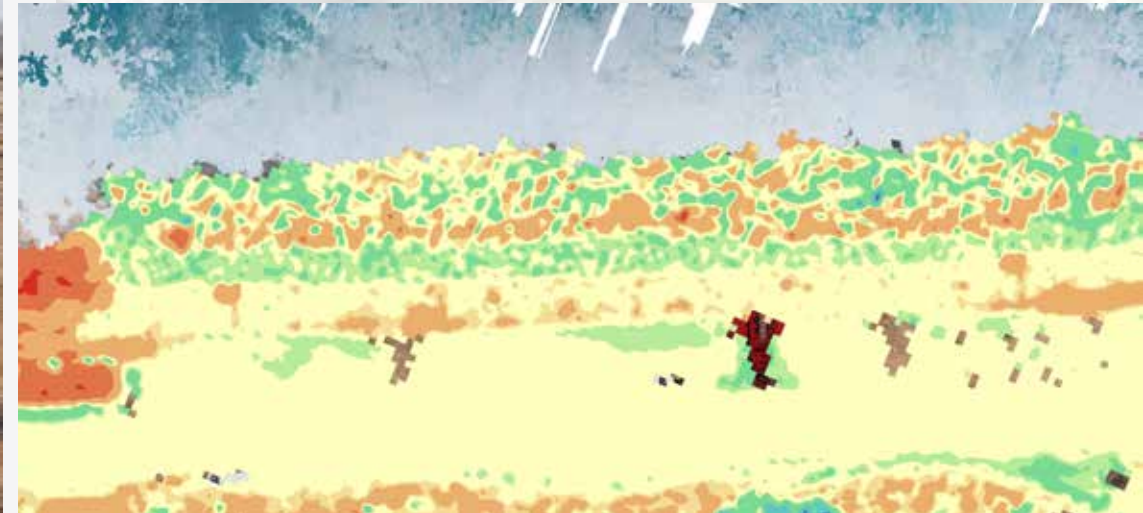
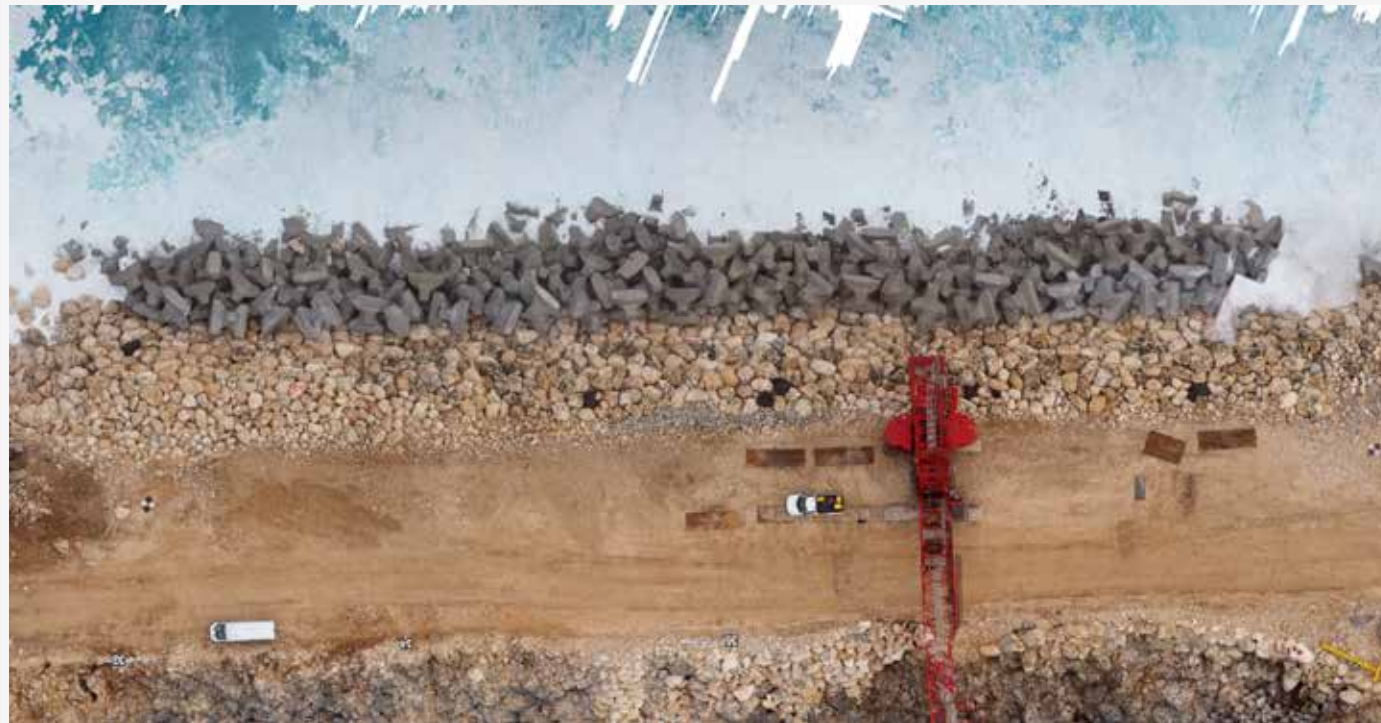
- Sinlaku related repairs completed
- Accropode™ Placement Completed for ~400ft
- Typhoon Bavi July 5-6<sup>th</sup>, 2026
- Placed units remained intact and stable
- Fewer Emergency Repairs required compared to Sinlaku

- Complete Emergency Repairs
  - Use imported stone from Korea to replace volume loss due to Sinlaku and Bavi
- Progress with the Permanent Repair Design with Accropode™
