# RELIC TO RESILIENCE THE GLASS BREAKWATER REPAIR PROJECT

# The Glass Breakwater - Apra Harbor, Guam

- Breakwater protects Port of Guam + Naval Base Guam
- Typhoon Mawar (May 2023) caused severe damage
  - à Apra Harbor Waterfront Repair Project
    - \$571M design-build project (NAVFAC)
    - Comprehensive repair of outer 5,800 ft of breakwater
    - Contractor - TPC-NAN JV (**Black Construction**)
    - Designer - **Baird** (+ AECOM, SEI, Woolpert, CLI, NRC)

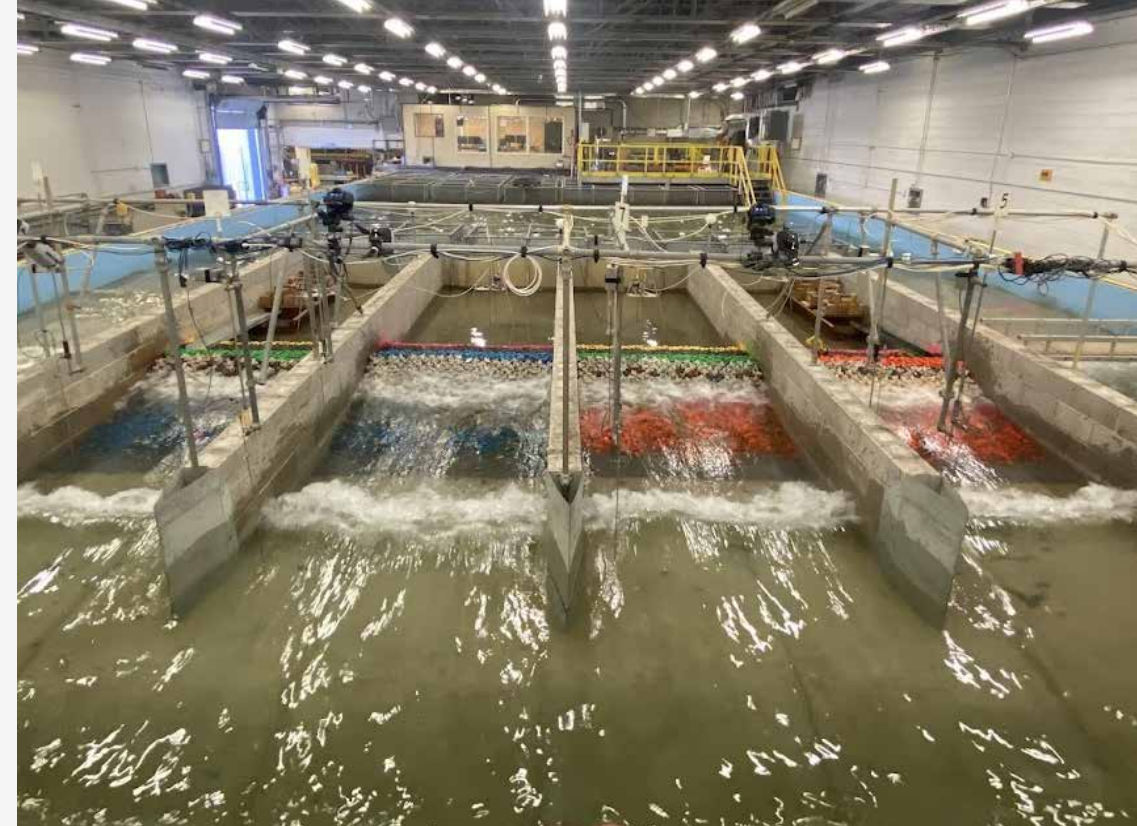
# 2D Physical Model Study

- Simultaneous testing of 4 XSs
- Damage to existing structure accurately simulated

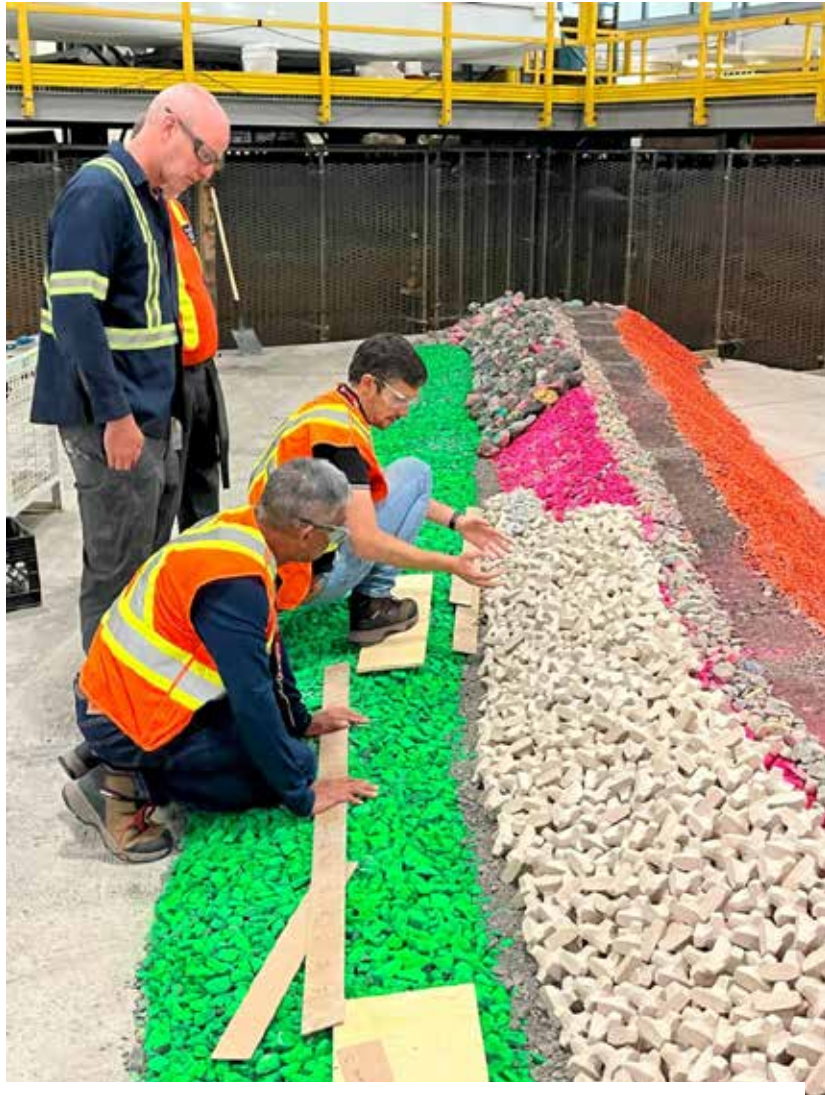
a) Accropode™ placement training along trunk

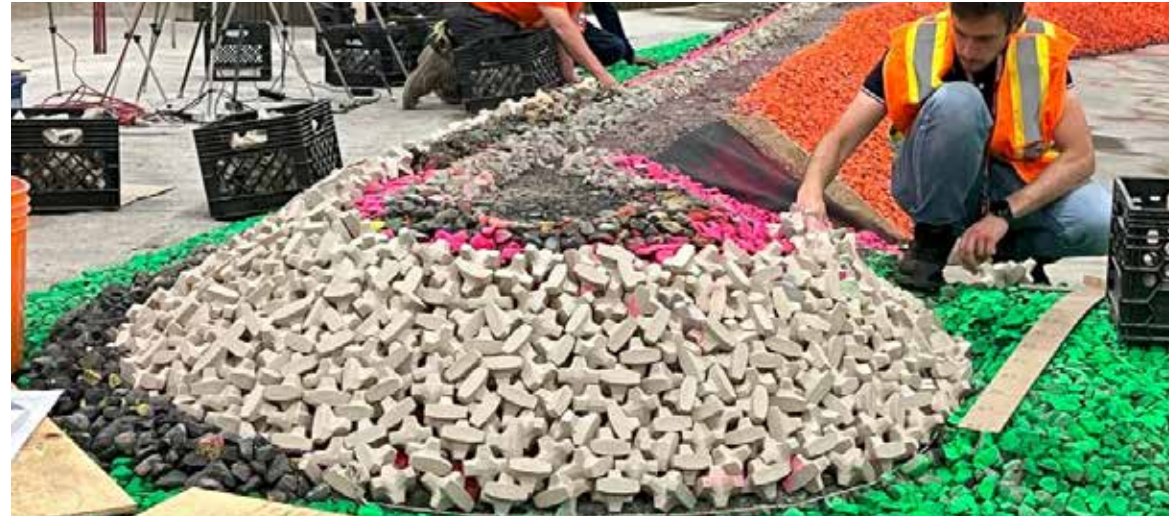
b) Accropode™ placement training along roundhead

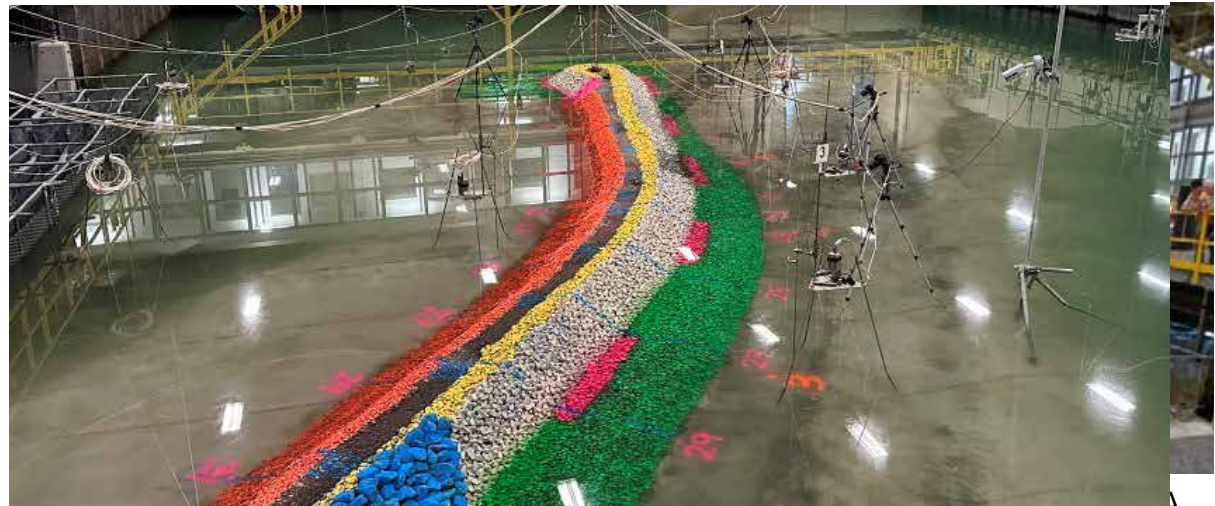
c) Completed 3D-W model (TSA)

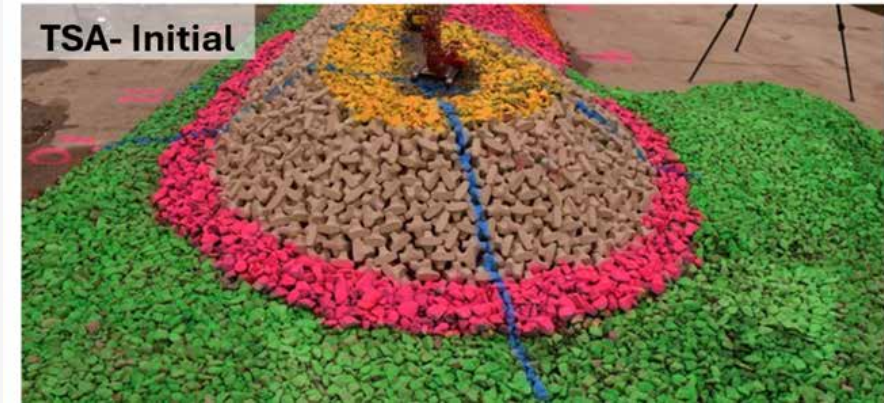
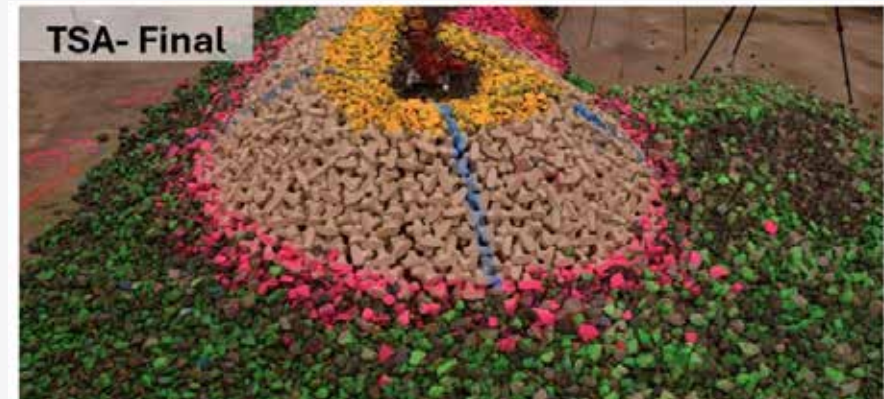
- 16 m<sup>3</sup> (42 T) Accropodes™ showed no sign of instability under design + overload conditions
- Armor layer provides significant design resilience
  - No extractions under extended duration of severe waves (multiple design events + overload conditions)
  - No progressive damage around artificially created gaps
- Extraction of a few toe units in some tests (3D-E model) after very long test durations (100+ yrs of storm exposure simulated)
